TOYOTA KUN26 HILUX 1KD-FTV

DIAGNOSIS ASSISTANCE FOR DAMAGED TURBO MOTOR DRIVER HARNESS

Relevant DTC affected: P0046, P0047, P0048, P1251, P2564, P2565, P2588, and P2589

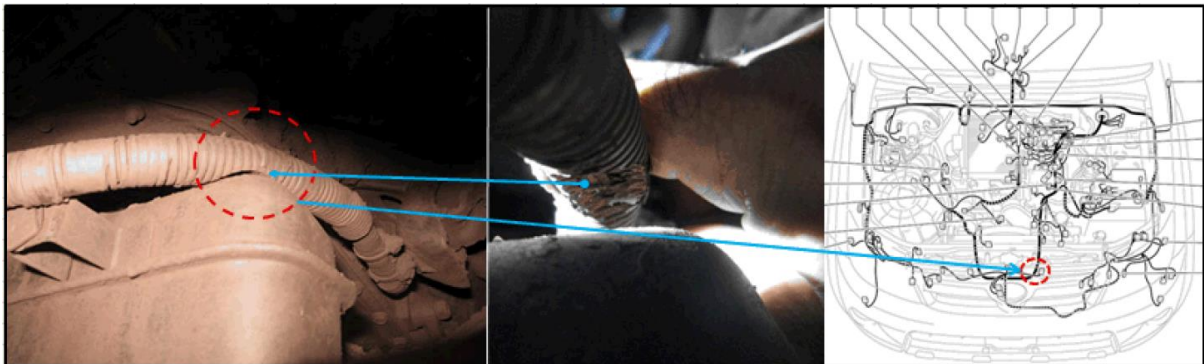
The wiring harness between the turbocharger DC motor and the turbo motor driver (located behind the glove box) has been found to be in close contact to the engine sump on the LHS of the engine, causing it to potentially rub through and consequently cause intermittent short or open circuit DTCs. Testing the resistance of the harness connectors can give a reading within specification however.

After working through the diagnostic flow chart for the relevant DTC to eliminate the turbocharger DC motor and the turbo motor driver from being at fault, inspect the wiring harness at the below point for damage.

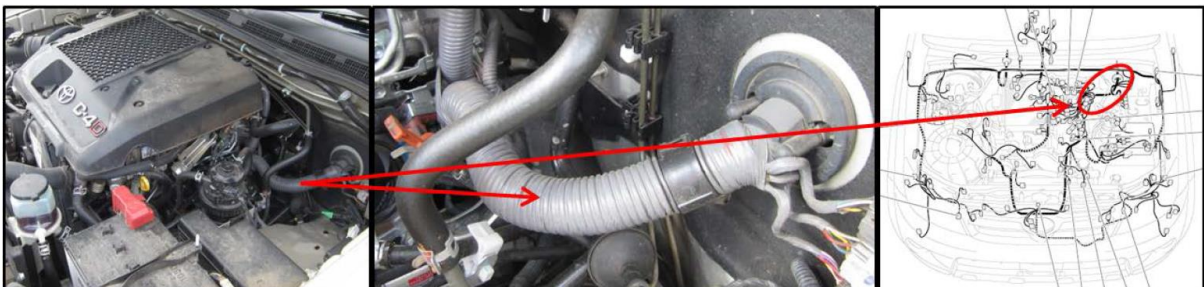
When checking the harness for continuity tests between the turbocharger DC motor and the turbo motor driver, ensure to manipulate the harness. A short or open circuit may only appear once the harness is manipulated and any broken or damaged wires (found between the firewall and engine) are disturbed. No fault may be found during diagnosis if the harness is not manipulated during testing.
